6. LESSONS LEARNED

6.2 Lessons from the Accident

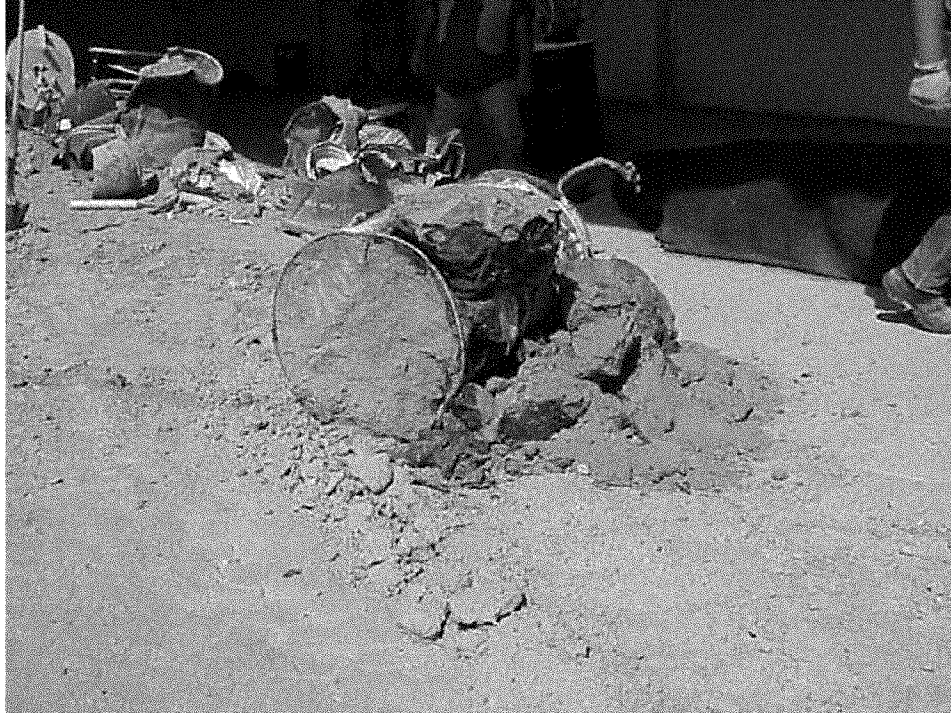
Figure 50. Nitrate drum removed from monolith with grout adhering to the surface of the drum.

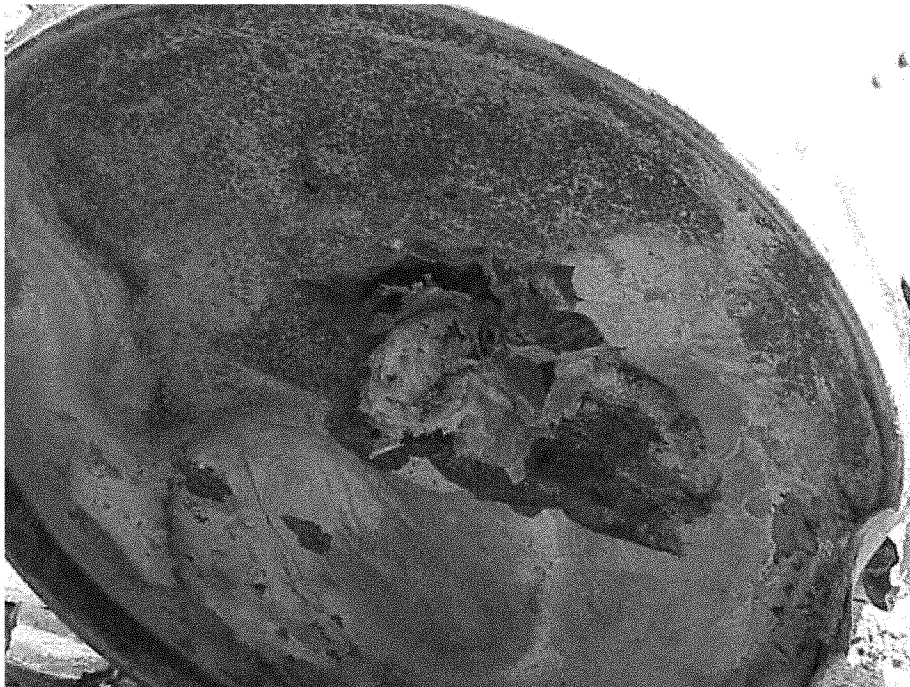
Figure 51. Drum with lid removed showing solid grouted interior with “J” seal visible about 12.7 cm (5 in.) into the top.

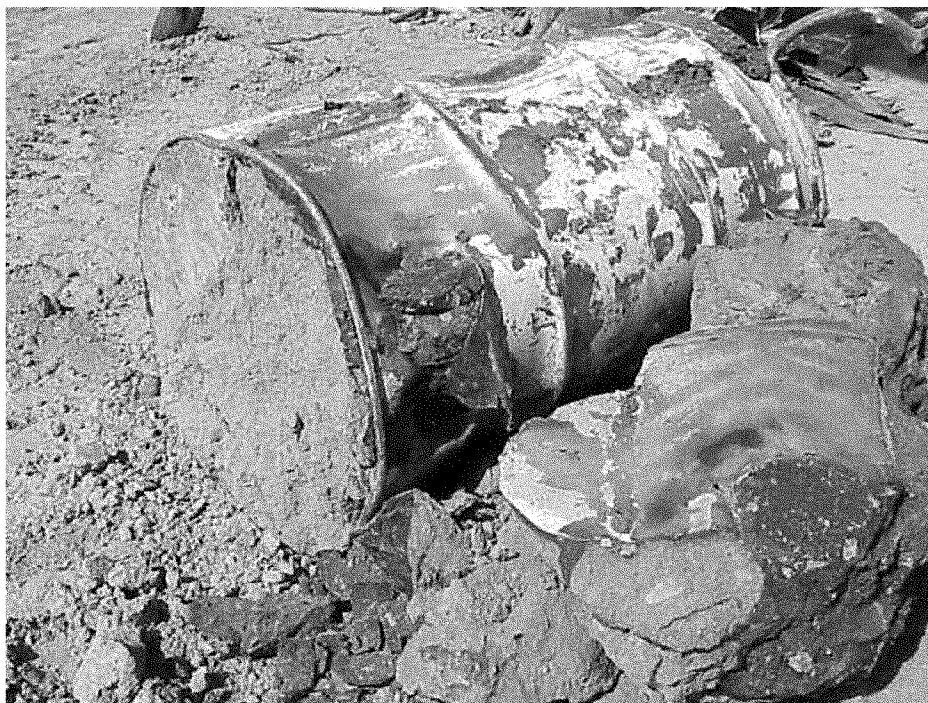
Figure 52. Puncture of drum by the drill steel (left-hand side of drum), showing the cylindrical shape of the drill steel.

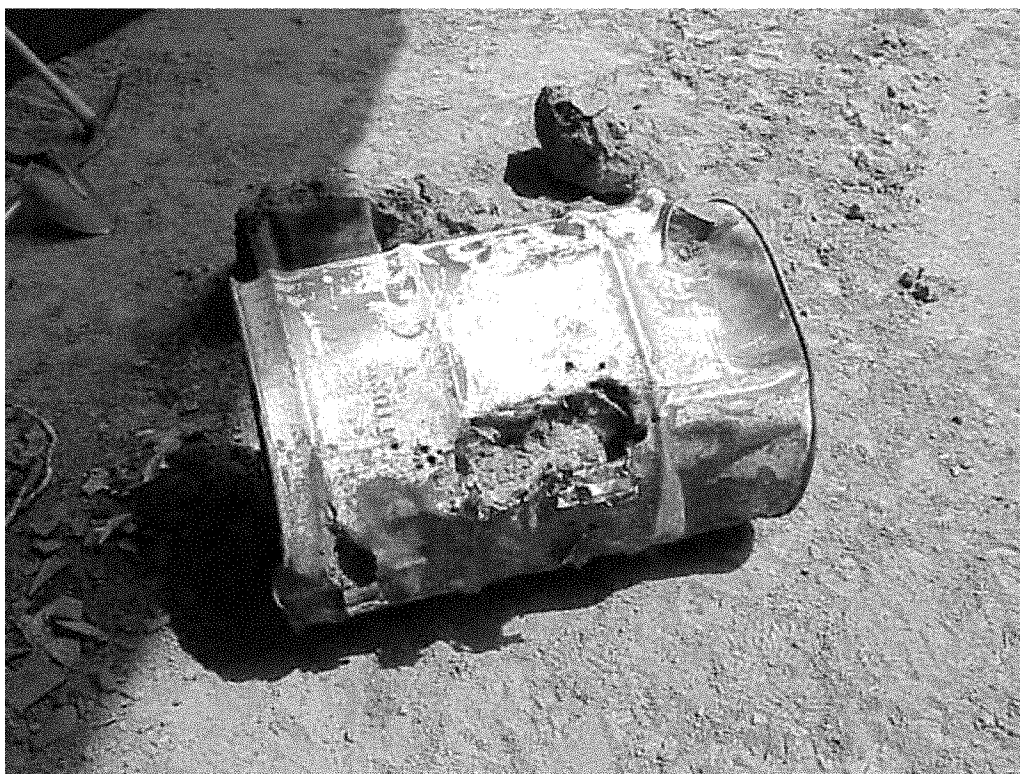
Figure 53. Hole in metal side of drum showing grouted nitrate salts in middle and neat grout on ends.

Accounting for a 5% weighing error, the most that could have been delivered to the drum would be the error ($0.05 \times 450 \text{ lbm} = 22.5 \text{ lbm}$) plus the 69 lbm or 41.5 kg (91.5 lbm). At 41.5 kg (91.5 lbm) there could have been at a maximum a total of 23L (6.1 gal) delivered to the drum which is much lower than the theoretical amount of 34L (9 gal) delivered based on the 22.8 cm (9 in.) of travel of the drill stem. With a 0.61m (2 ft) diameter in the drum there is approximately 7.2L (1.9 gal) of volume per inch of drum height. Therefore, if 23L (6.1 gal) had been injected into the drum, a linear total of 8.1 cm (3.2 in.) of empty drum length could have been completely filled. This then supports the idea that the grouting action only filled the peripheral edges where there was a large void. If the drum had been struck straight on by the drill stem and further that there was a full 60.9 cm (24 in.) of travel then the amount of grout delivered into the drum would have roughly tripled (as much as 102 L [27 gal]). This action would have certainly filled all voids in the drum and most likely even overflowed a mixture of nitrate salts and grout into voids surrounding the drum.

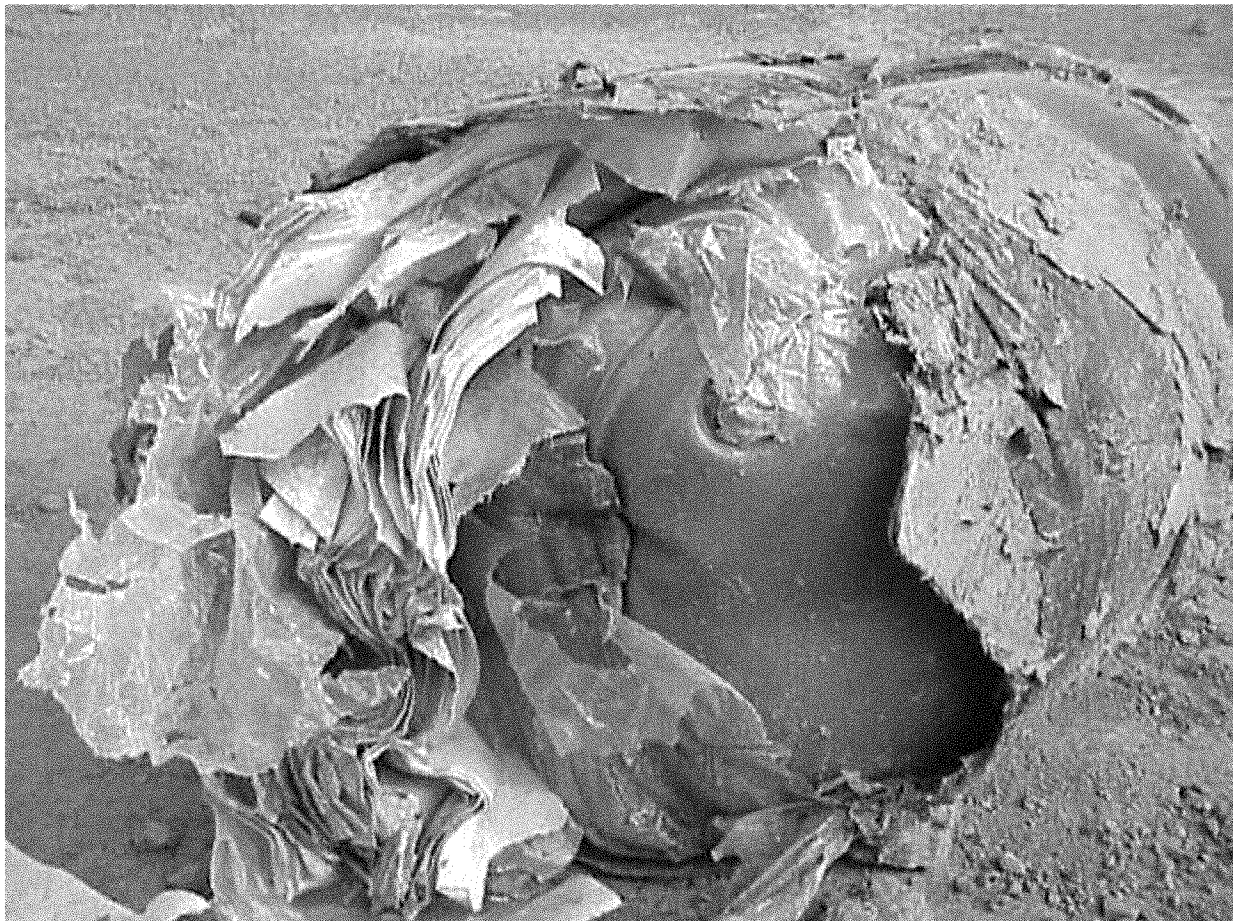
As the excavation proceeded, two more recognizable waste forms were photographed including a grouted drum containing combustible material and material from the 1.2 x 1.2 x 2.4-m (4 x 4 x 8-ft) box. Figure 54 shows the grouted combustible drum, and Figure 55 shows the grouted boxed material.

The fact that these two simulated waste containers had grout means that the terbium tracer in the containers could have spread to the top surface of the thrust block and to other positions within the contamination control system.

Figure 54. Grouted drum containing combustibles.

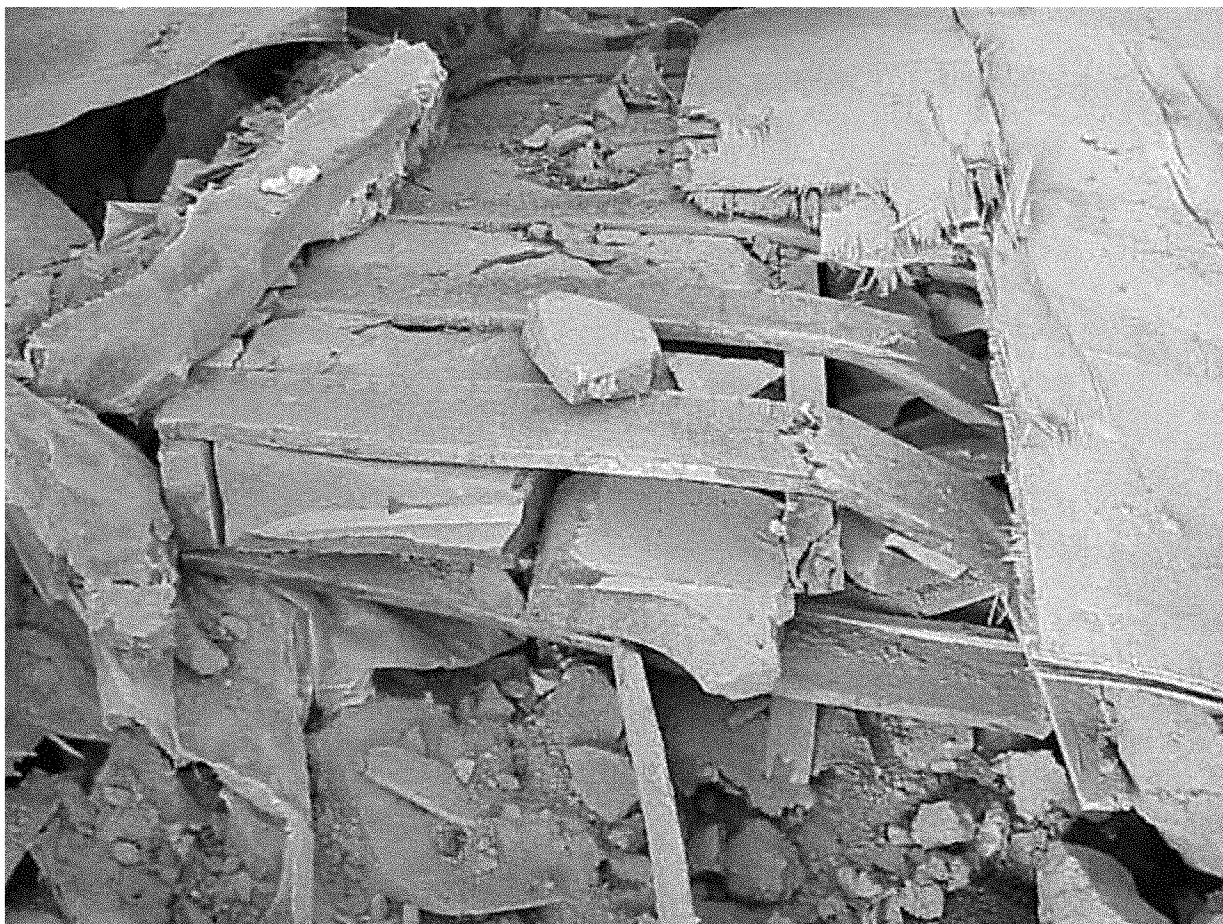
Figure 55. Grout in contents of $1.2 \times 1.2 \times 2.4$ -m ($4 \times 4 \times 8$ -ft) box.
